Photo Log

Mark Ford Training Center

CWA Section 404 Inspection: September 22, 2016

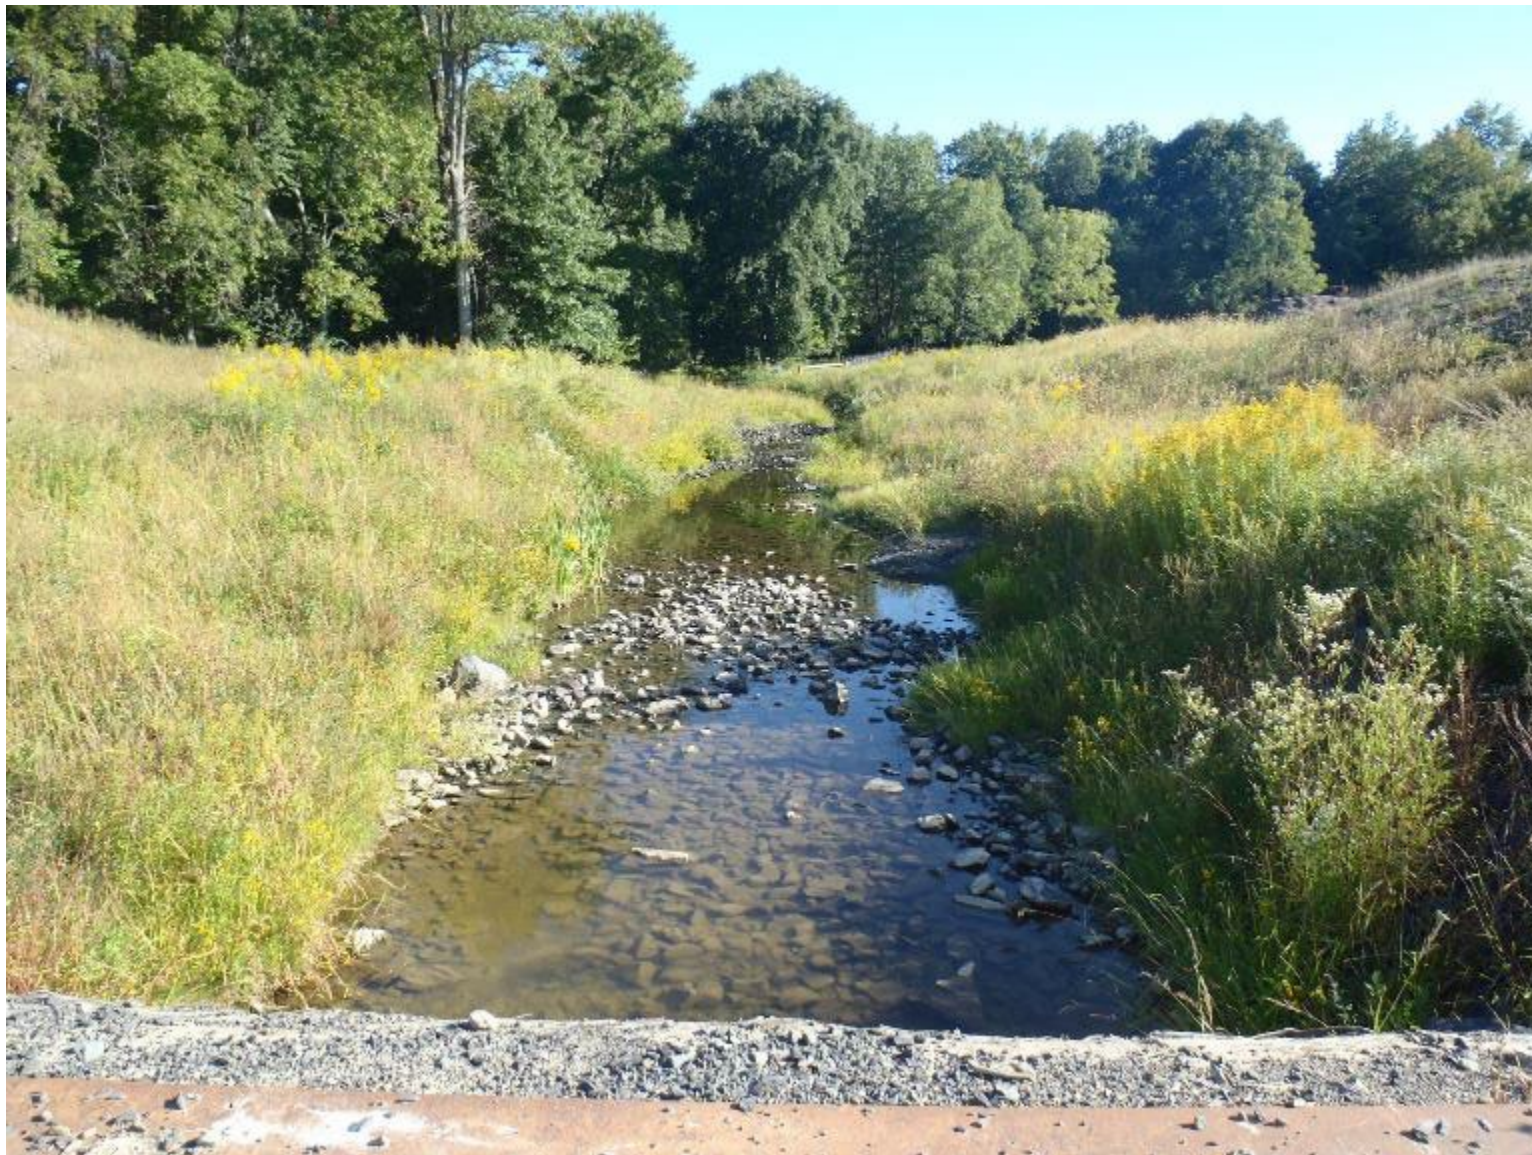
P9220042 – Straightened Stream, Looking Downstream from Small Bridge
